Building Envelope Remediation & Related Work

The Gables Condominiums Indian Rocks Beach

Preliminary Summary Report

Project No. 122033

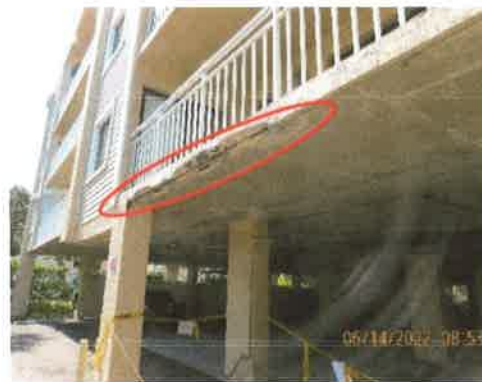
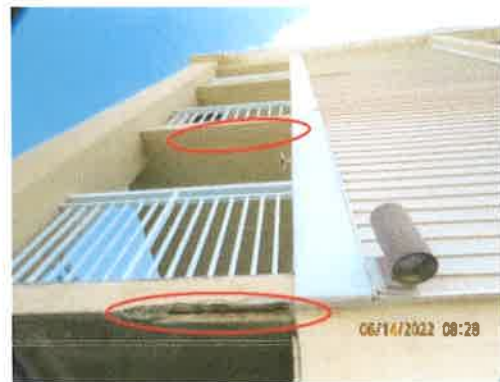
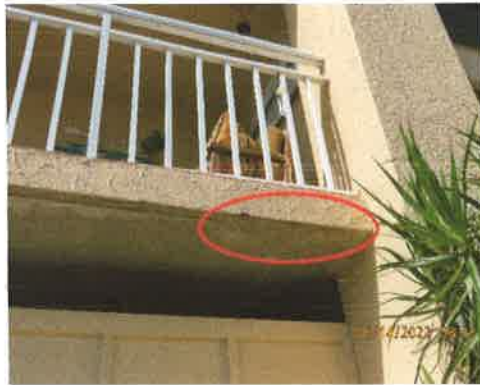
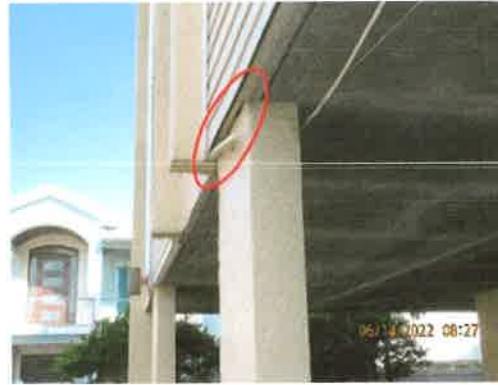
- 2.1 Concrete spalling is occurring along the balcony edges on all elevations at various stages, see photos 1, 2, 3 and 4

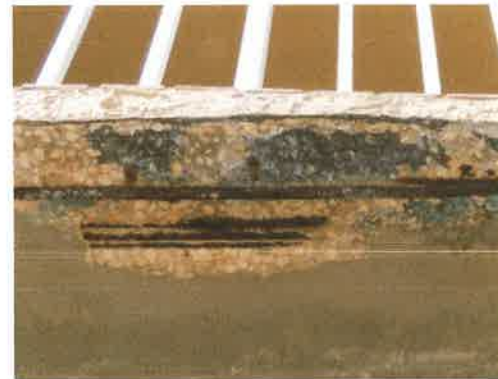
Photo 5 061422sm 089

Section loss of the steel reinforcing rebar is evident in all areas observed, see photo 5.

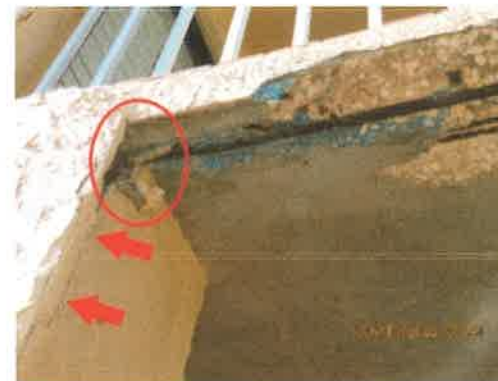
Photo 6 061422sm 092

Corrosion of the steel reinforcing rebar extends within the structural columns. Cracking of the stucco cladding is indicative of concealed corrosion, see photo 6.

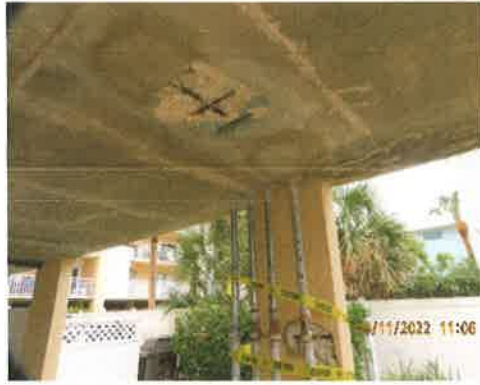
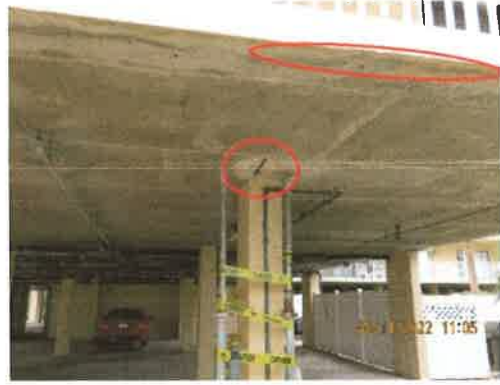
2.2 Parking Garage Temporary shoring has been installed within the parking garage as a precaution in two areas due to the ongoing steel rebar reinforcement corrosion resulting in spalling of the concrete, see photos 7, and 8.

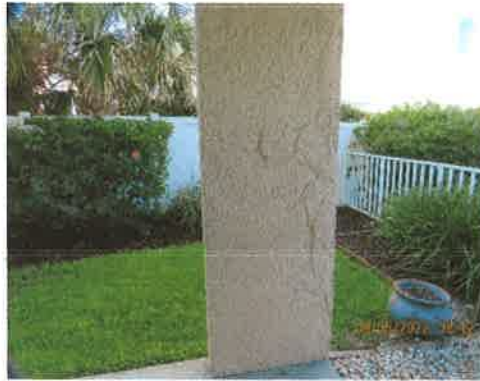
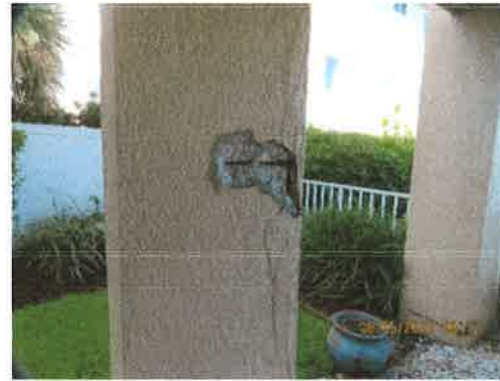
Stucco cladding was observed spalling and removed, revealing corrosion of the column reinforcing rebar. Temporary shoring was installed, see photos 9, and 10.

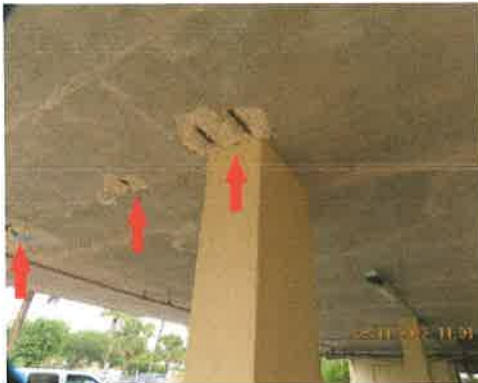
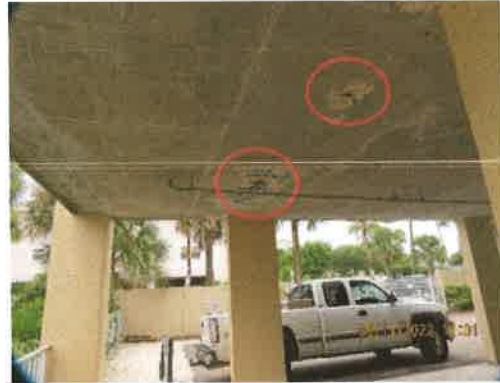
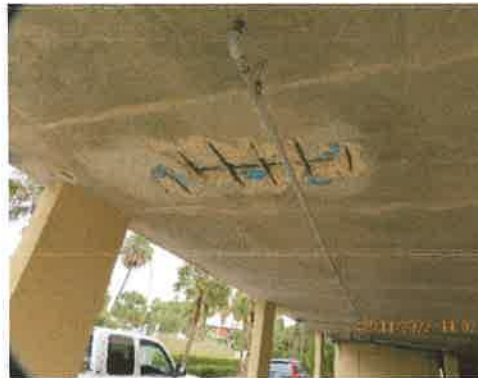
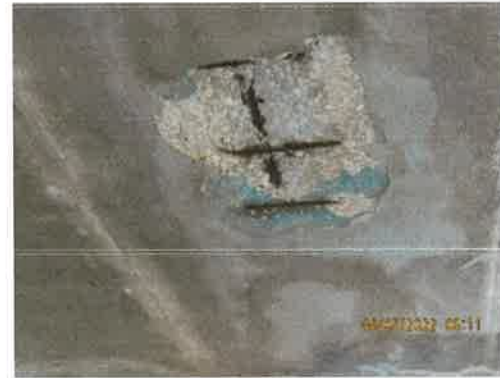
Multiple areas of concrete spalling within the parking garage ceiling were observed. Some of the areas coincide with the balconies and are related to the sliding glass doors above, see photos 11, 12, 13, and 14.

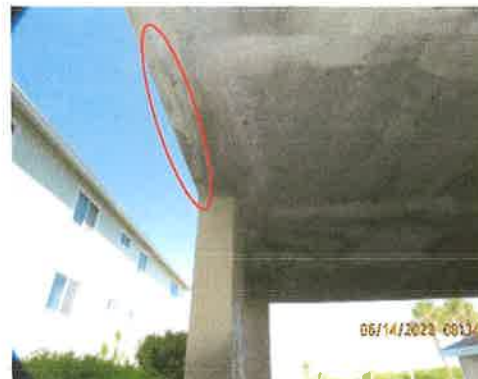
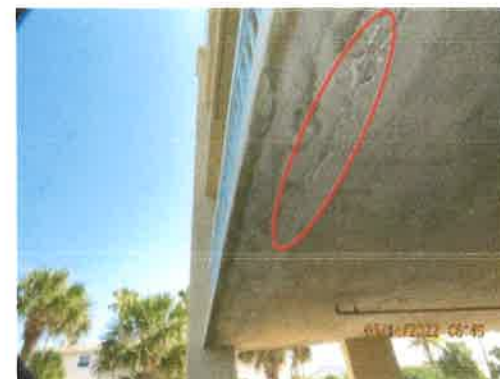
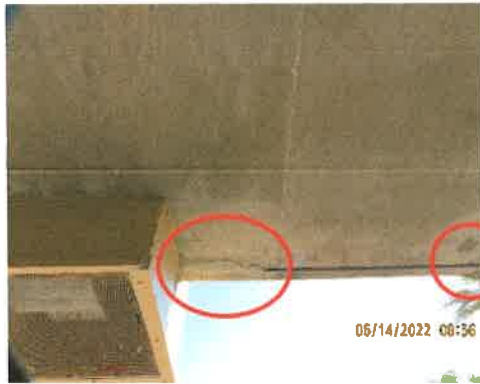
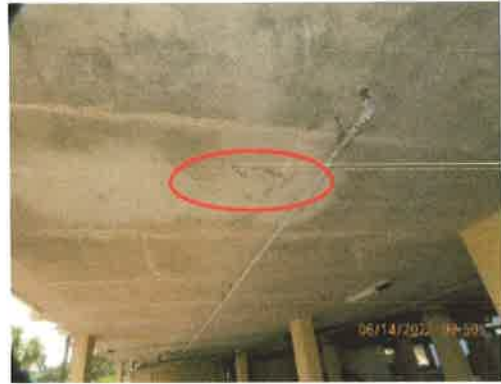
2.2.1 Past Repairs Inspection of the parking garage ceiling revealed multiple areas of past repaired concrete patches. Evidence of current water migration within the repairs was noted and spalling beginning, see photos 15, 16, 17, and 18.

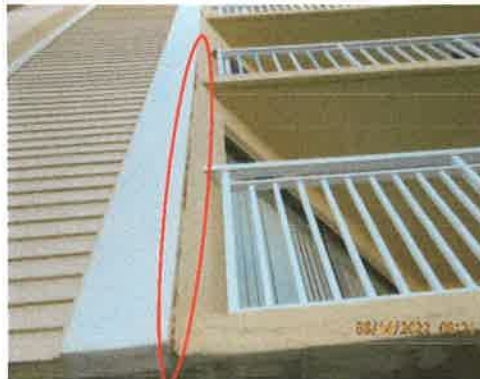
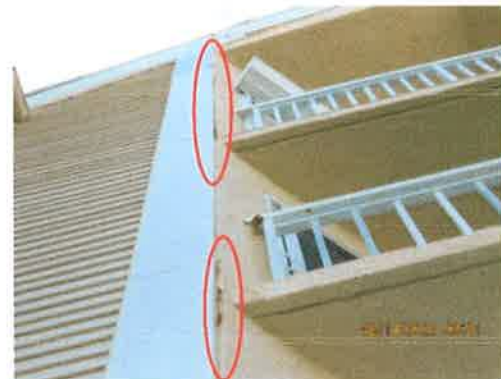
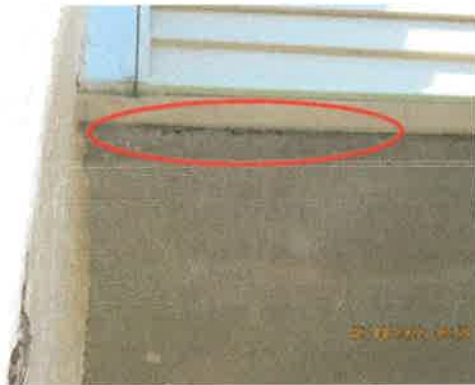
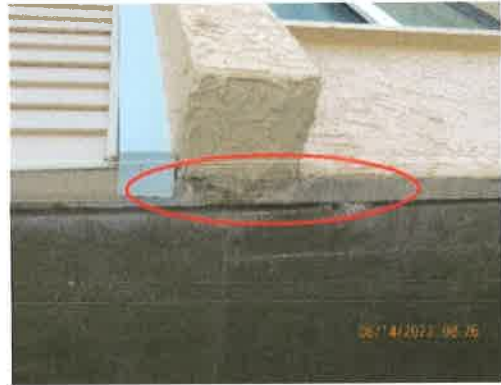
Evidence of water migration was observed migrating from under the vinyl siding vertical trims. Staining was noted from the floor slab edges and running down the building indicating that the metal framing and sheathing are possibly compromised due to water intrusion, see photos 19, 20, 21, and 22.

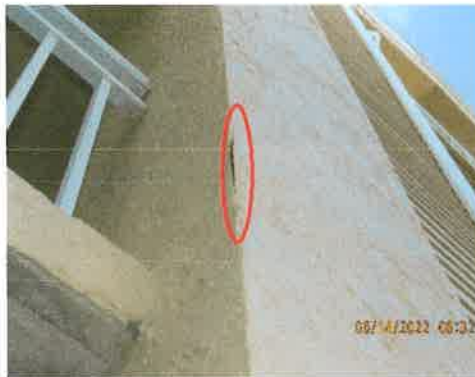
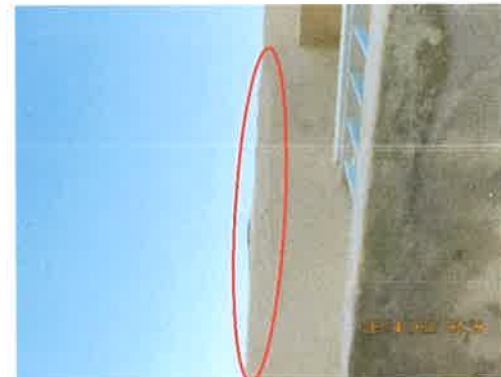
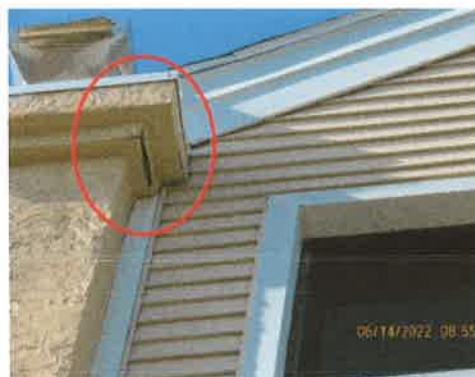
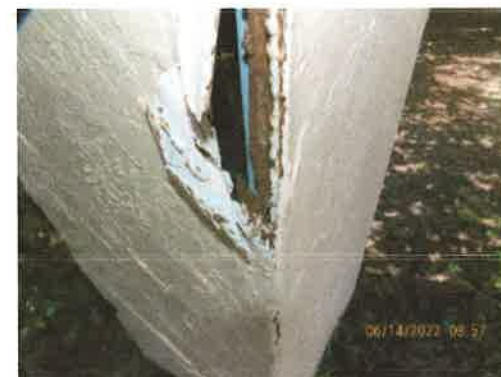
2.3.1 Evidence of water migration was observed migrating from under the stucco cladding on the walls and columns indicating that the metal framing and sheathing under the cladding is possibly compromised due to water intrusion, see photos 23, 24, 25, and 26.

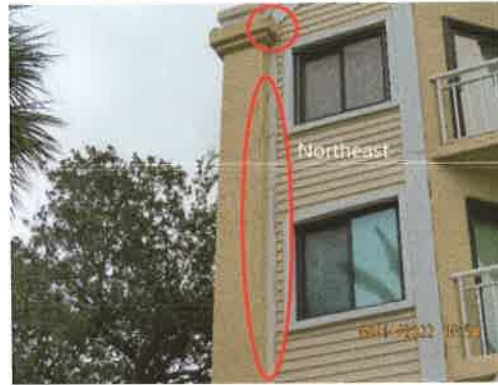
Photo 27 081122sm 460

Water staining and corrosion along the stucco and vinyl siding and trim, see photo 27.

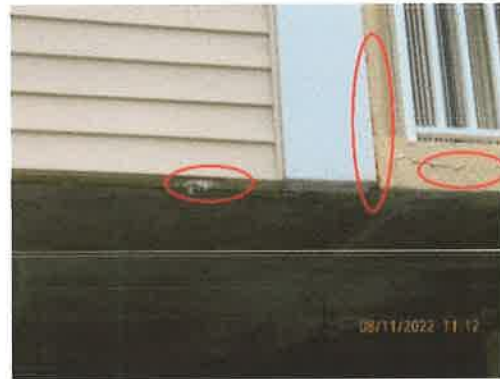
Photo 28 081122sm 530

Water staining and corrosion along the stucco and vinyl siding trim and slab edge concrete spalling, see photo 28.

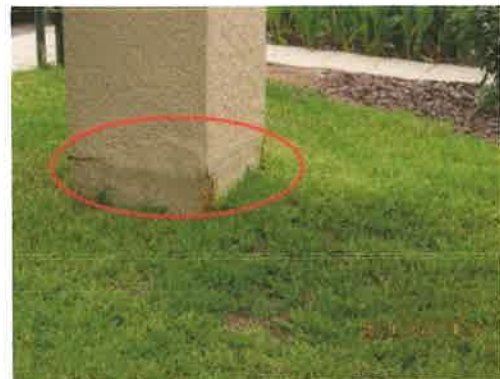
Photo 29 081122sm 552

Water staining, corrosion, and spalling along the stucco column base, see photo 29.

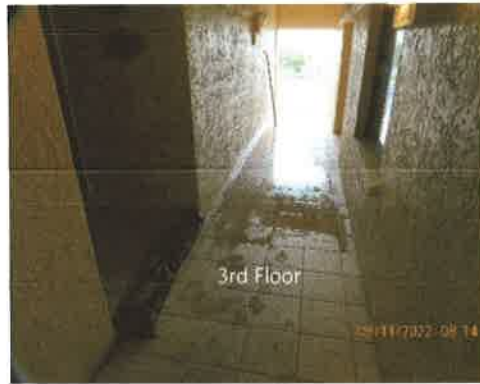
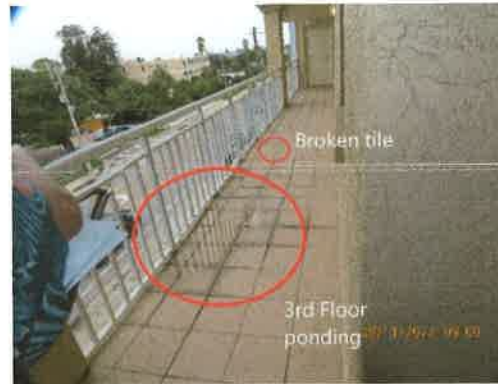
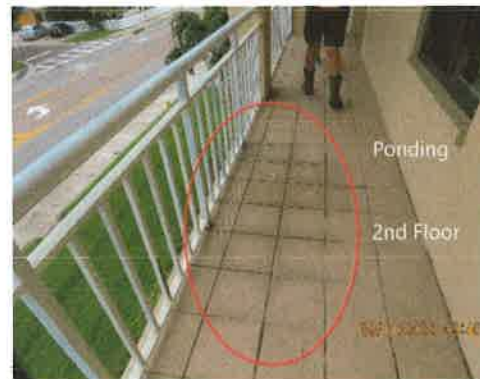
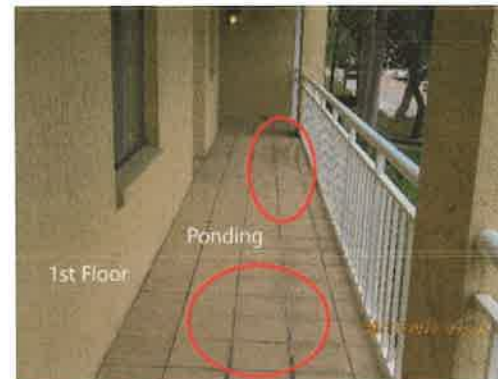
2.4 Walkways Inspection of the walkways revealed standing water and some broken tiles and heaving due to a lack of adhesion to the substrate on all floors along the east and north elevations, see photos 30, 31, 32, and 33.

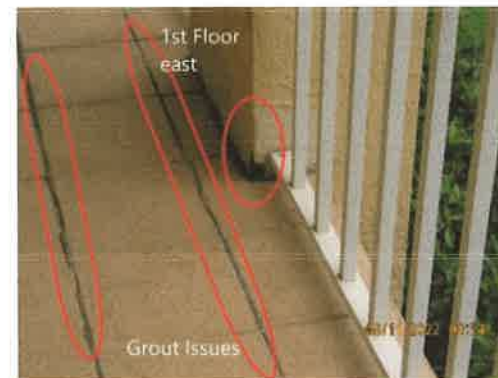
Photo 34 081122sm 225

Voids within tile grout and missing grout along with void in the stucco are allowing for water migration under the tile, see photo 34.

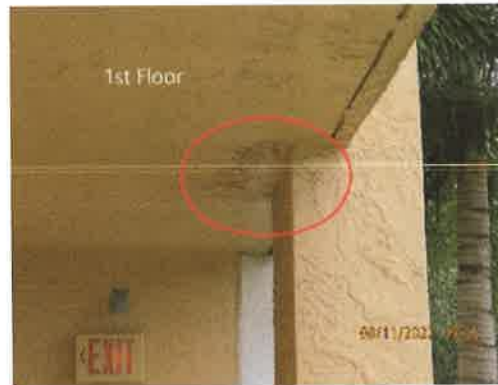
Photo 35 081122sm 229

Past repair patch spalling due to water migration at the ceiling to column interface, see photo 35.

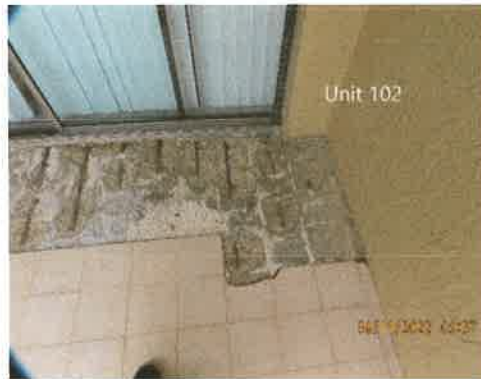
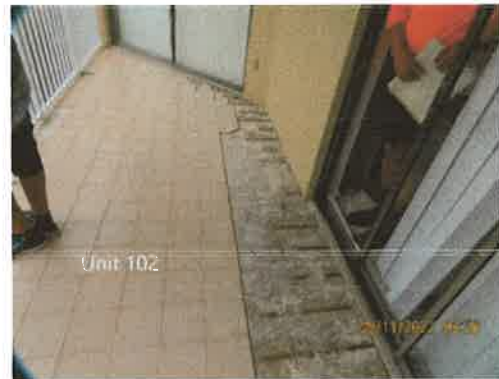
2.5 Balconies Inspection of the residential balconies revealed extensive damage section loss to the slab reinforcing rebar under the floor tile, see photos 36, and 37.

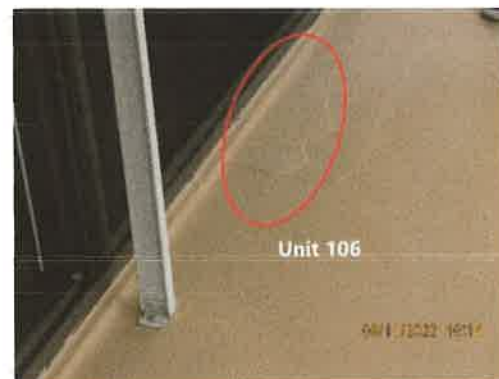
Photo 38 081122sm 289

Separation of the waterproofing along the sliding glass door track due to moisture was noted, see photo 38.

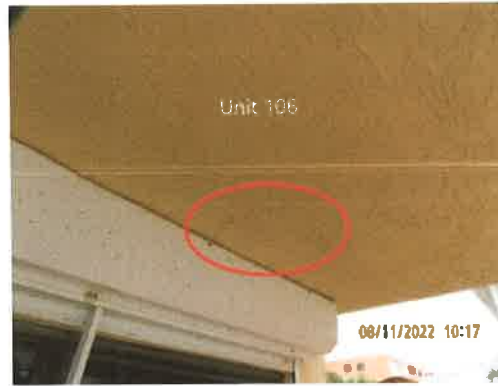
Photo 39 081122sm 312

Spalling of the concrete stucco finish on the balcony ceiling was noted indicating moisture within the substrate, see photo 39.

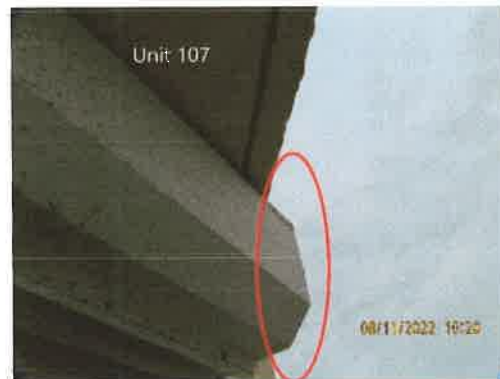
Photo 40 081122sm 322

Typical to all existing storm shutter housings installed have an overhang that allows for water to migrate between the housing and ceilings, see photo 40.

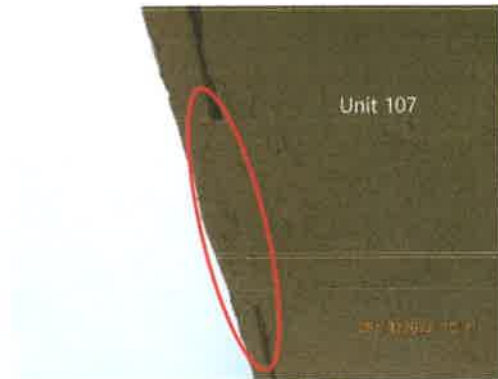
Photo 41 081122sm 324

Typical to all past balcony ceiling edge repairs, the stucco covers the drip-edge riglet allowing for water migration under the stucco, see photo 41.

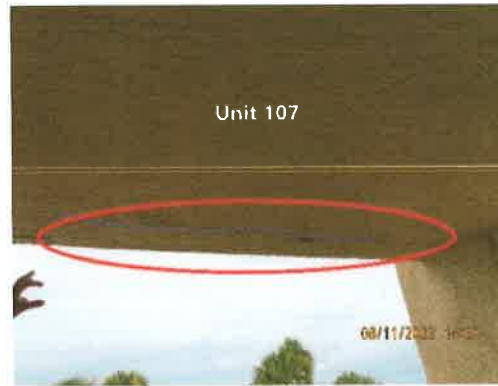
Photo 42 081122sm 344

Spalling of the balcony ceiling stucco finish revealed water migration under the stucco, see photo 42.

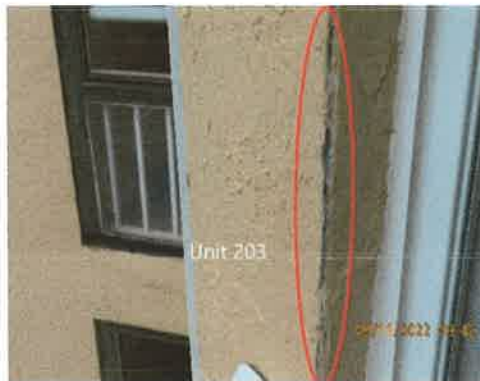
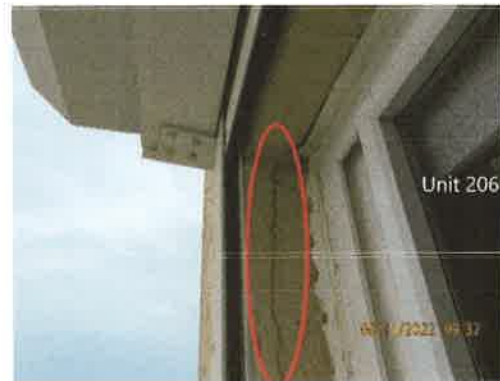
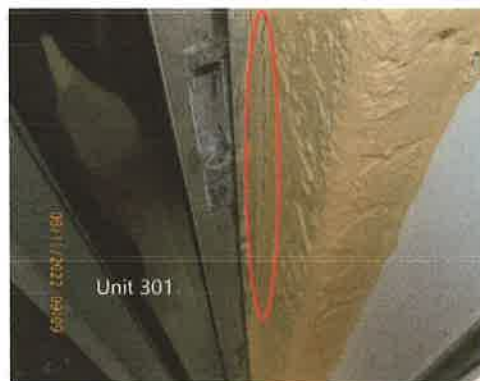
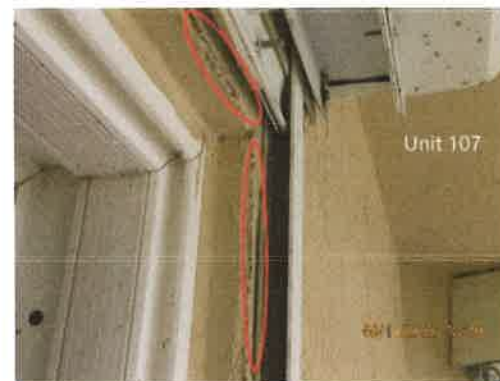
Cracks within the stucco cladding along the balcony walls and voids in the sliding glass door sealant perimeter were found in multiple areas allowing for water migration within the wall cavities, see photos 43, 44, 45, and 46.

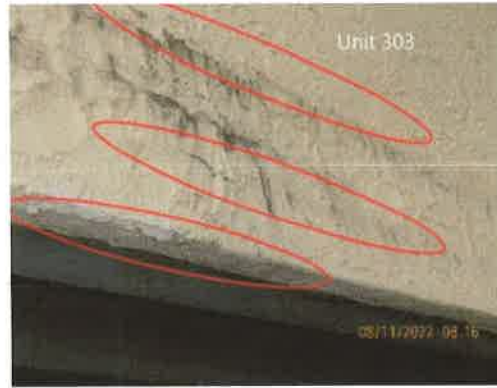
Photo 47 081122sm 013

Horizontal cracks within the stucco and water migration through the cracks was observed at the sliding glass door header, see photo 47.

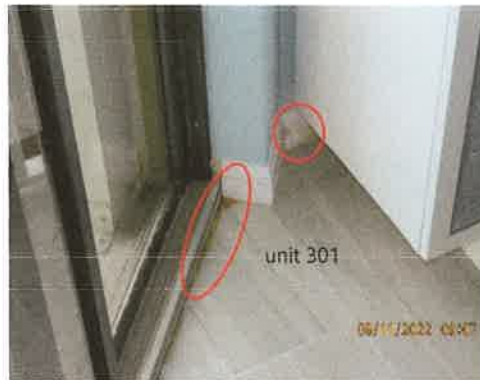
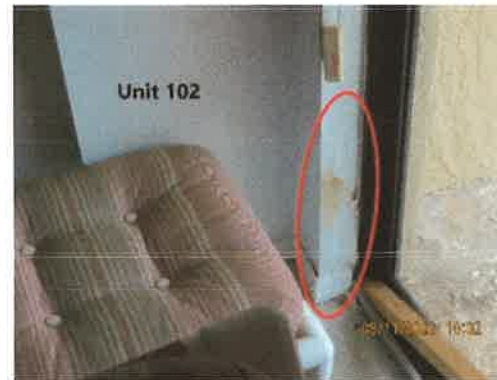
Water damage was noted within some of the residential units migrating from around the sliding glass doors and wall cavities. Staining revealed the metal framing is compromised due to water infiltration, see photos 48 and 49.

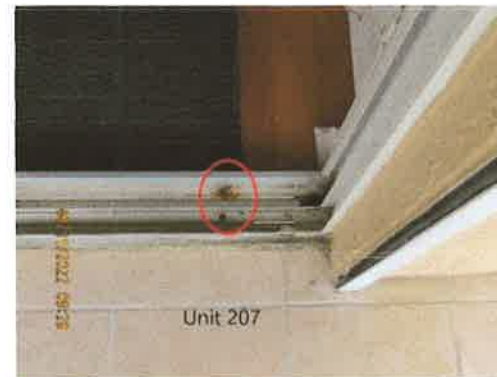
Photo 50 081122sm 142

Observations of mostly the original sliding glass door tracks revealed corroded and/or missing track anchors and the lack of waterproofing sealant which allows for water migration into the concrete slab, see photo 50.

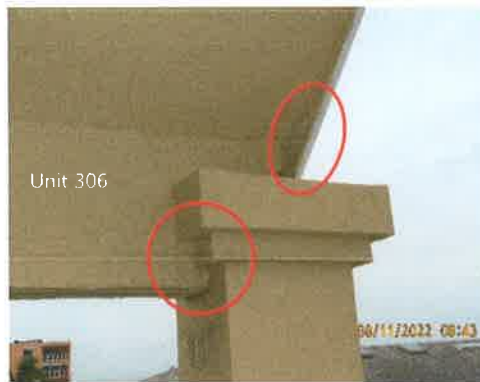
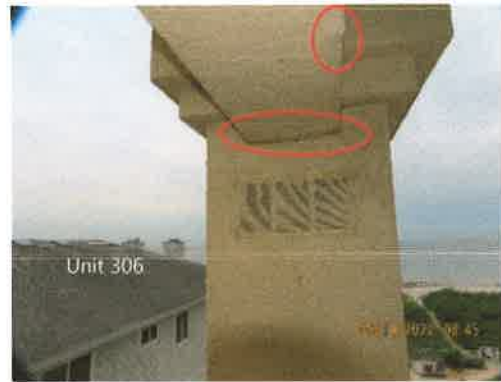
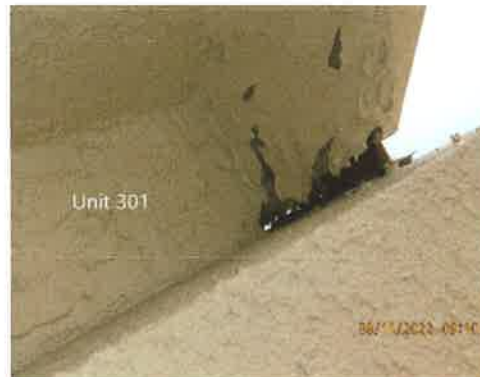
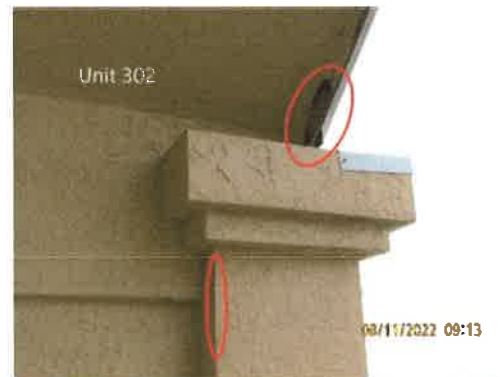
Damage due to water infiltration was found along the 3rd-floor balcony soffits, column corbels, and roof fascia, see photos 51, 52, 53, and 54.

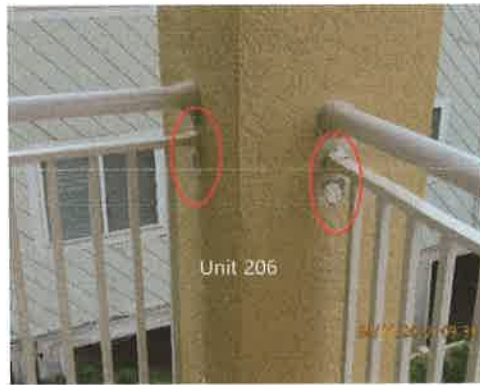
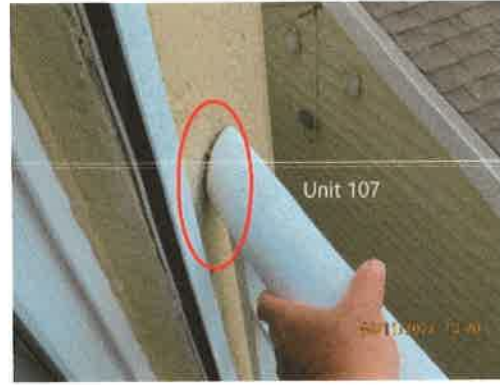
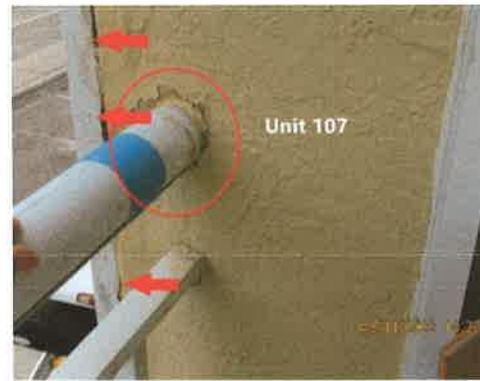
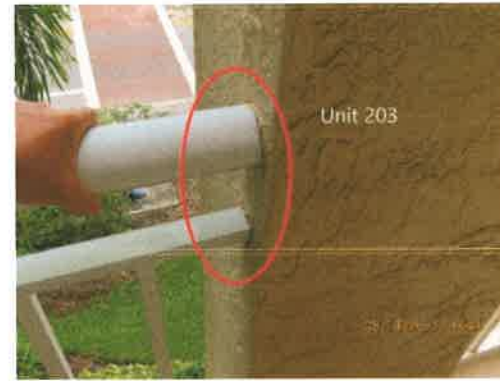
2.5.1 Balcony Railings Inspection of the balcony railings revealed loose attachments, exposed concrete, holes in the structure, and corroded anchors, see photos 55, 56, 57, and 58.

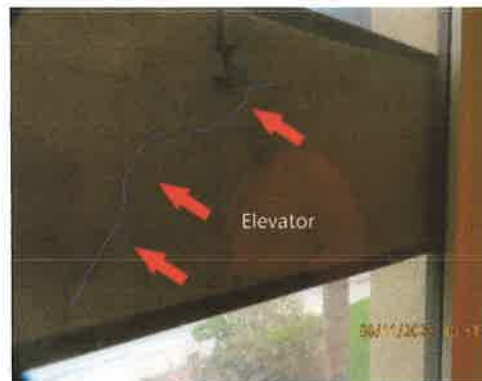
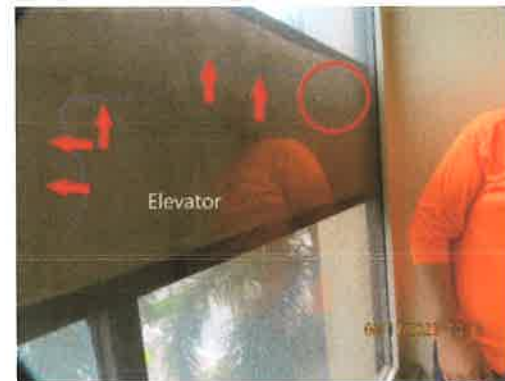
2.6 Elevator Inspection of the elevator shaft spandrel along the 2nd and 3rd levels revealed cracks within the beams and spalling of the concrete, see photos 59 and 60.

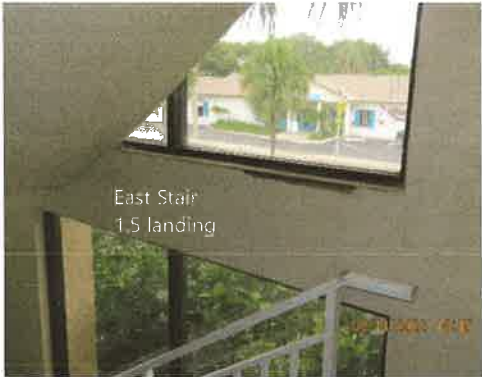
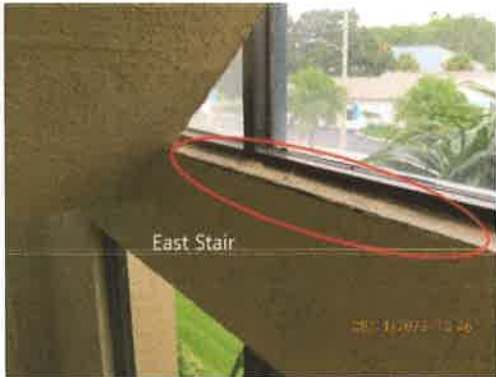
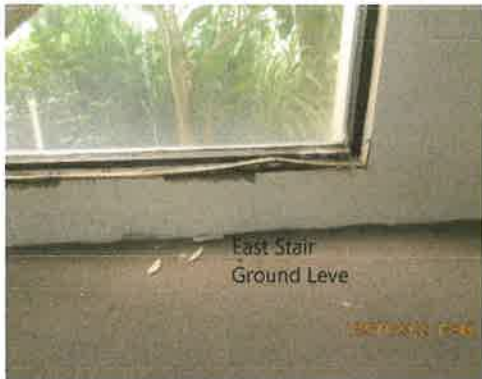
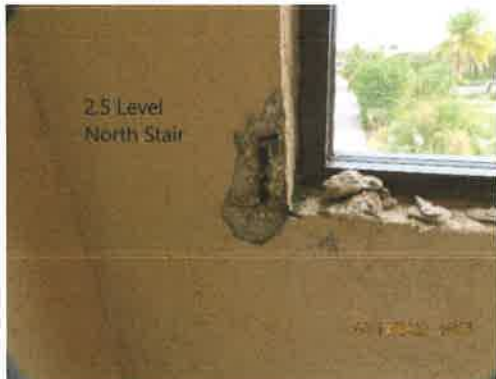
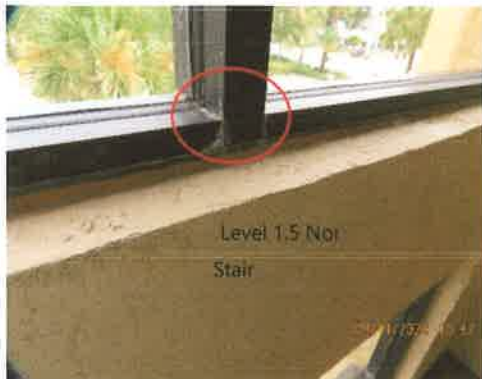
2.7 Stair Towers Inspections of both the north and east stair towers revealed extensive damage due to water infiltration at and around the fixed storefront windows, see photos 61 thru 65.

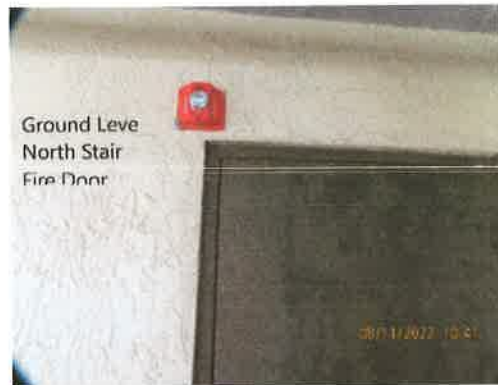
Photo 66 081122sm 400

The north stair tower ground-level fire door panel, hinges, and frame is heavily corroded, see photo 66.
