## COMMERCIAL WINDSTORM MITIGATION REPORT

The Gables Condominium Association, Inc.

## COMMERCIAL WINDSTORM MITIGATION REPORT (OIR-B1-1802)

1108 Gulf Blvd, Units 101-307

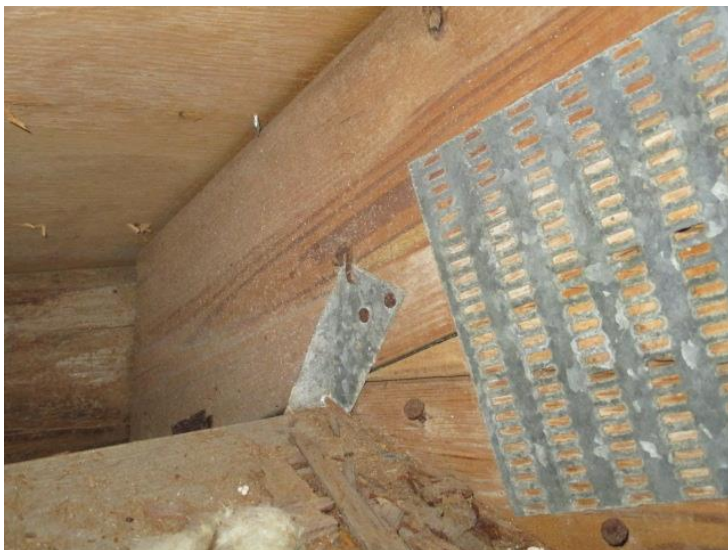
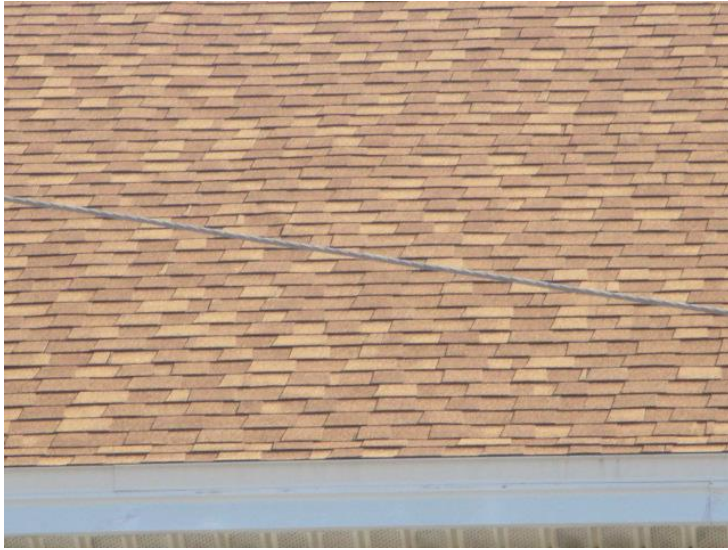
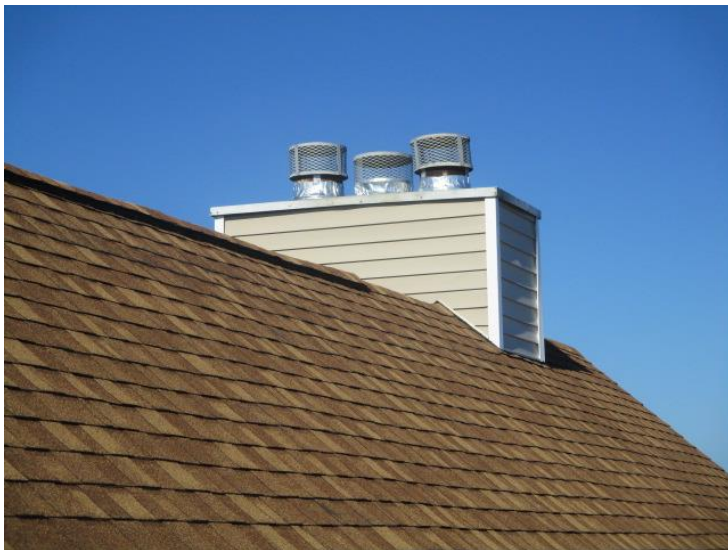
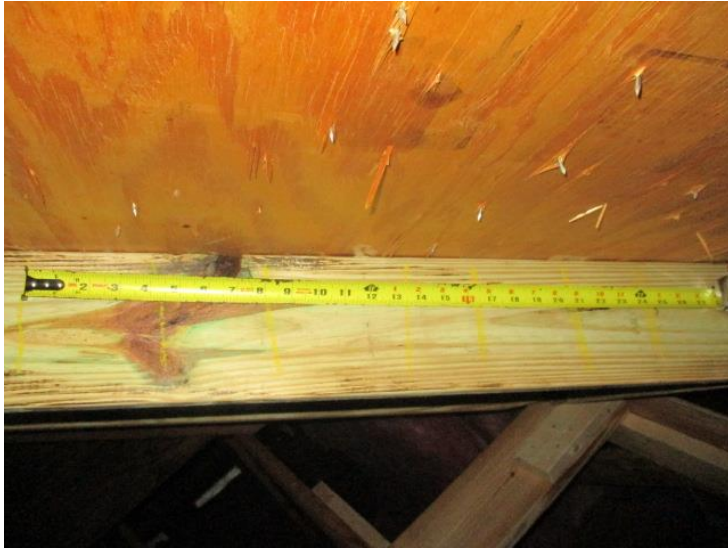
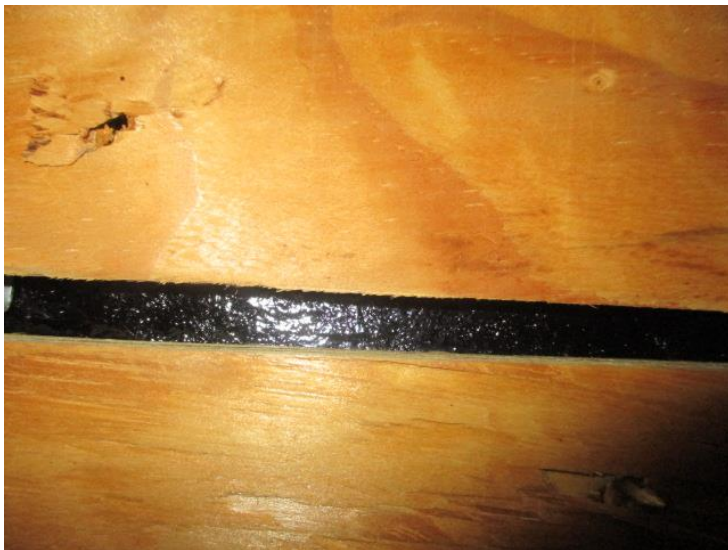
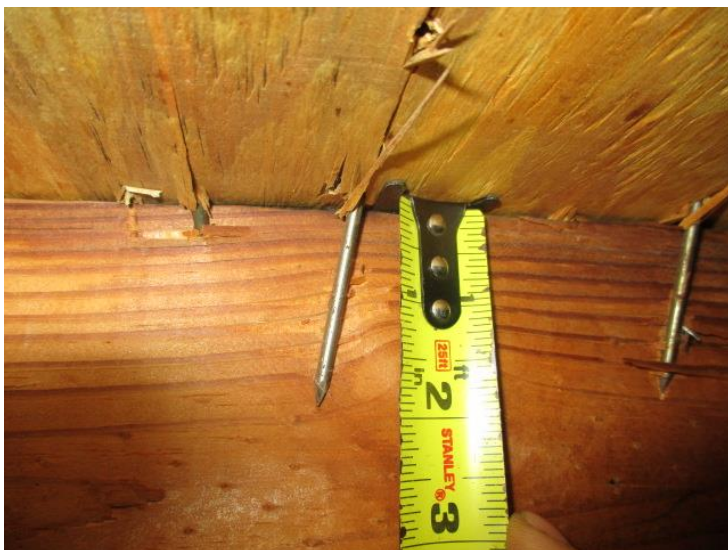
Roof Construction

3. **Roof Deck Attachment:** **Level C**  
Comments: Inspection verified 1/2" plywood roof deck attached with 8d nails at a minimum 6" on the edge & 6" in the field.

4. **Roof to Wall Attachment:** **Clips**  
Comments: Inspection verified hurricane clips fastened with a minimum of three nails.
5. **Roof Geometry:** **Other Roof**  
Comments: Inspection verified a gable roof shape.

6. **SWR:** **Yes**  
Comments: SWR was verified at time of inspection. The Secondary Water Resistance verified is a self-adhering peel and stick.
7. **Opening Protection:** **None or Some Glazed Openings**  
Comments: Inspection verified some metal shutter opening protection. Not all glazed openings were protected with impact resistant coverings.

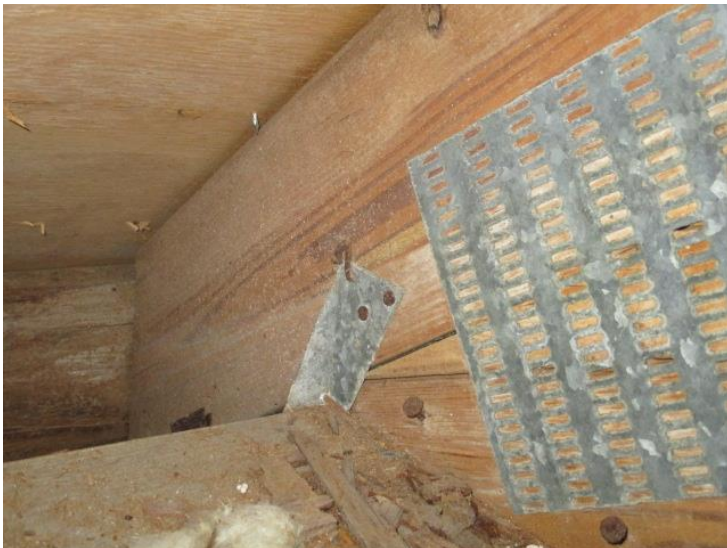
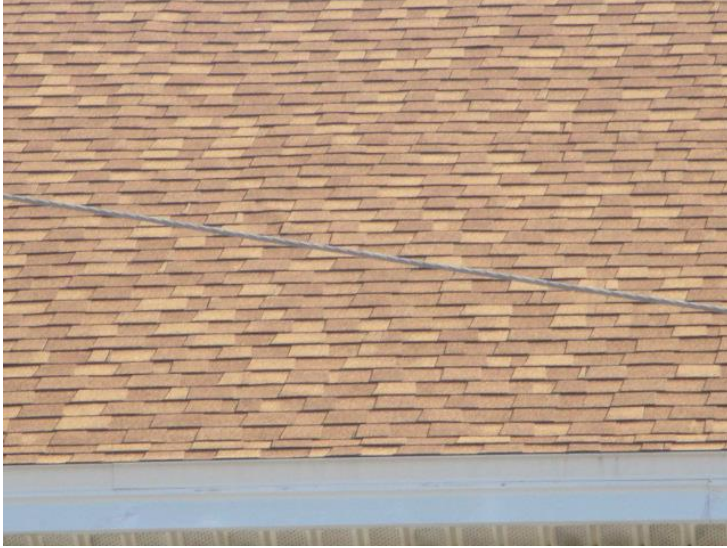
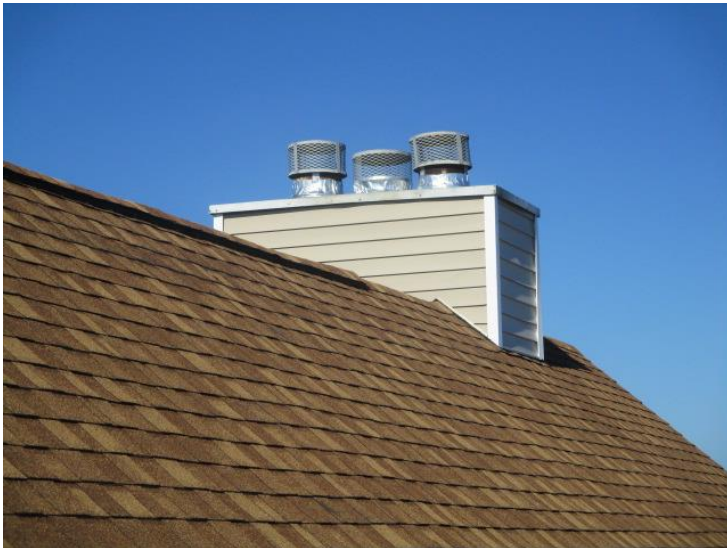
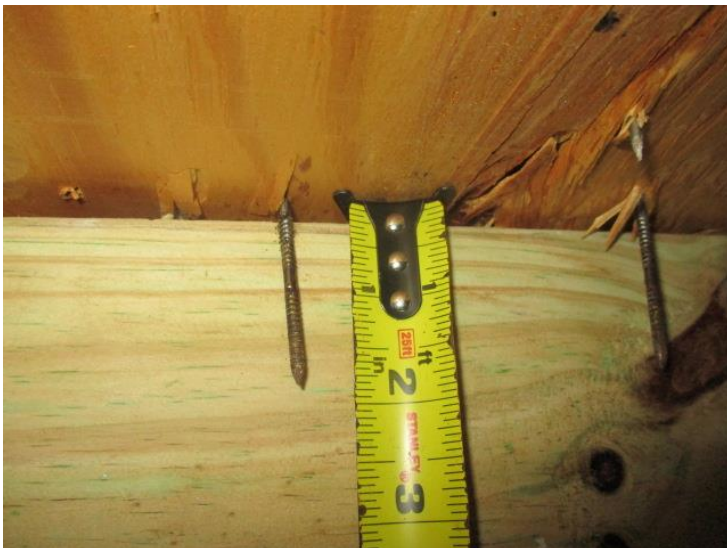
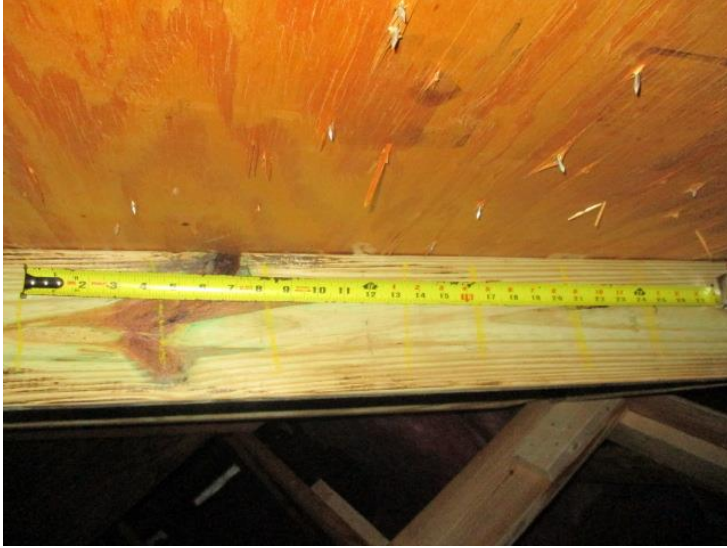
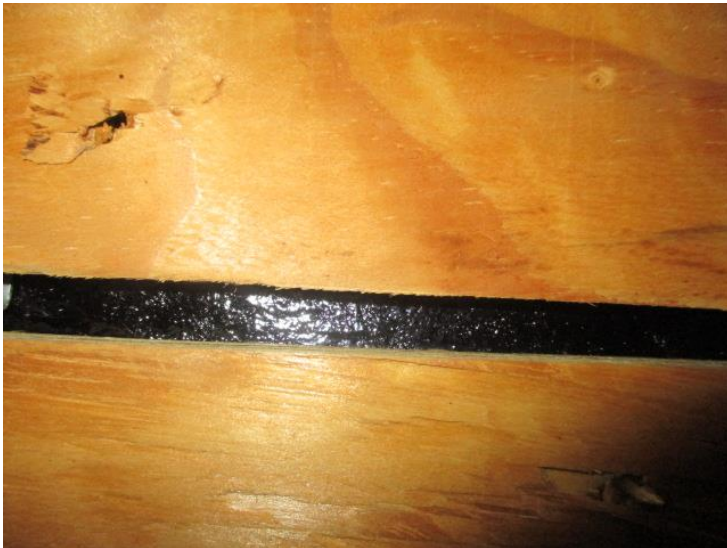
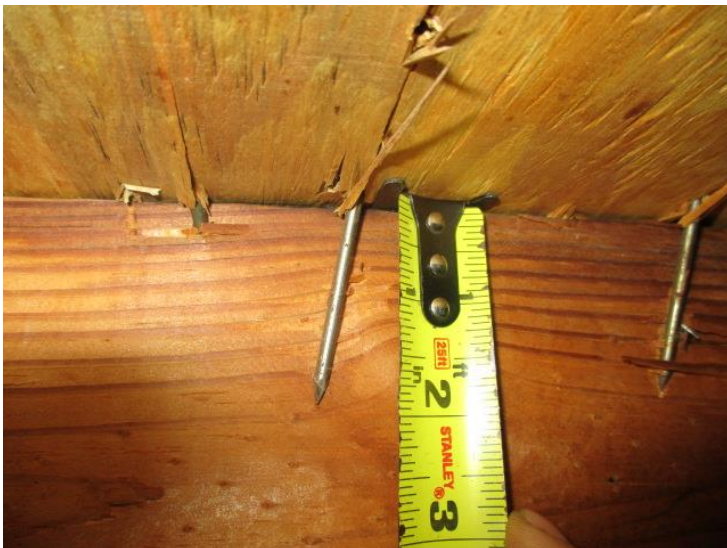
Roof Construction

- 1. Roof Covering:** **FBC Equivalent**  
Comments: The roof covering was replaced in 2018. The roof permit was confirmed and the permit number is 2018326. This roof was verified as meeting the building code requirements outlined on the mitigation affidavit.
- 2. Roof Deck Attachment:** **Level A**  
Comments: Inspection verified 1/2" plywood roof deck attached with 8d nails at a minimum 6" on the edge & 6" in the field.
- 3. SWR:** **Yes**  
Comments: SWR was verified at time of inspection. The Secondary Water Resistance verified is a self-adhering peel and stick.
- 4. Opening Protection:** **None or Some Glazed Openings**  
Comments: Inspection verified some metal shutter opening protection. Not all glazed openings were protected with impact resistant coverings.
