## COMMERCIAL WINDSTORM MITIGATION REPORT (OIR-B1-1802)

The Gables Condominium Association, Inc.

1108 Gulf Blvd, Units 101-307

As of 4/18/2019

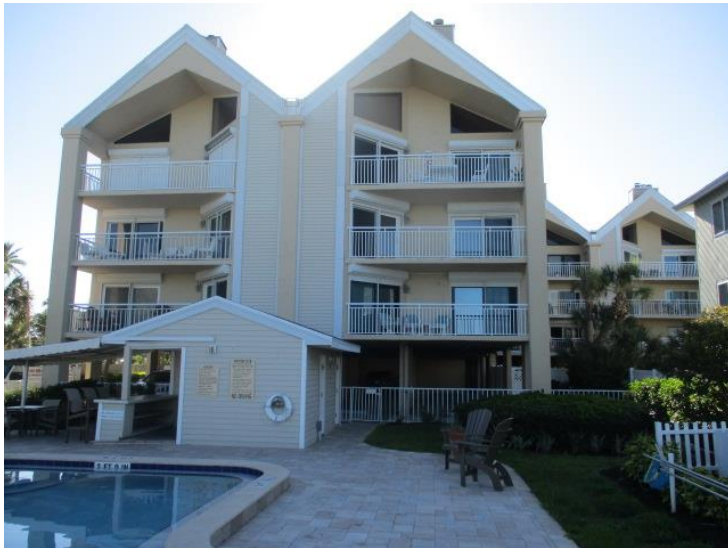
Exterior Elevation

4. **Roof to Wall Attachment:** **Clips**  
Comments: Inspection verified hurricane clips fastened with a minimum of three nails.
5. **Roof Geometry:** **Other Roof**  
Comments: Inspection verified a gable roof shape.
